WARRANTY INSPECTION REPORT

123 Anywhere St, Westminster, CO

Inspection Date: xx/xx/xxxx

Your Inspector: Matt Wachter

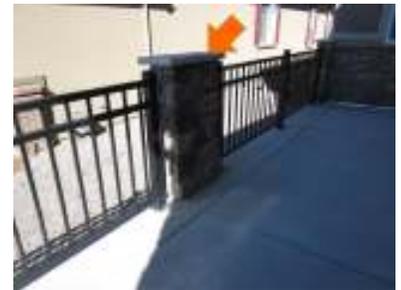
The center stone post on the front patio was very loose where it attaches to the patio. This poses a safety issue. Correction would involve securing the post to the concrete.

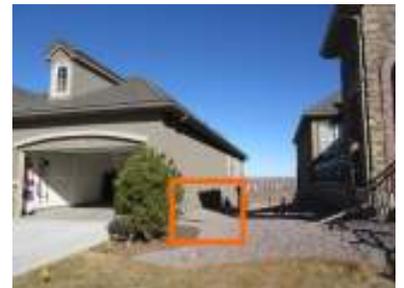
Areas were observed around the house where the landscaping is not properly sloped to direct surface water away from the structure, most notably at the right of the house towards the front. This can lead to surface water saturating the soil resulting in moisture entering basements/crawlspaces and possible structural settling of the foundation. Correction will involve adjusting the landscaping slopes downward at least 1" per foot for the first several feet away from the house, covering the areas with landscaping fabric or visqueen then installing a landscaping decorative material such as rock or mulch.

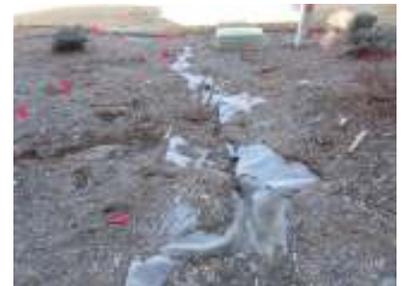
The landscaping was observed to be washed away where water from runoff has flowed over it. Correction would involve installing an underground drain or installing a strip of heavier landscaping material in that area that will not wash away.

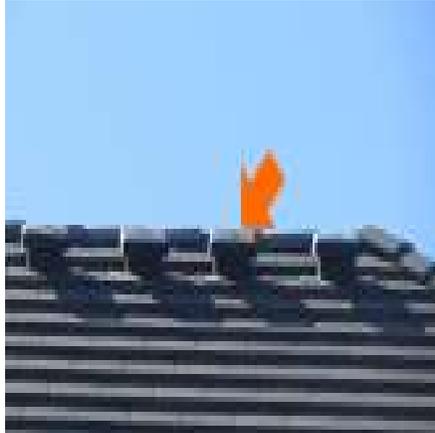
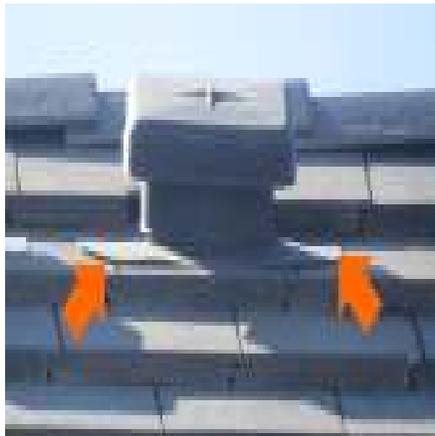
One of the metal bases to a turtle vent at the rear of the house (second from right) was canted to one side. The vent may have been installed this way and is working as intended, or it may be loose and not weather proof potentially causing a leak. Correction would involve verifying and potentially correcting installation.

One of the metal bases to a turtle vent at the rear of the house was canted to one side. The vent may have been installed this way and is working as intended, or it may be loose and not weather proof potentially causing a leak. Correction would involve verifying and potentially correcting installation.

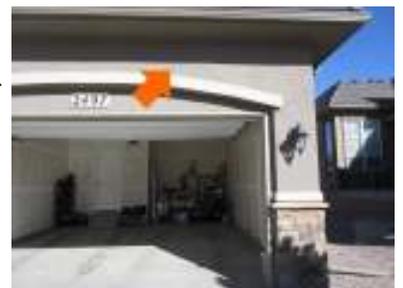
A small blemish in the stucco surface directly above the garage door was observed. Correction should involve a minor repair.

STUCCO: This appears to be a modern "hardcoat" stucco installed on this house. The stucco system appeared to be properly installed and in good overall condition for its age. A small blemish in the stucco surface directly above the garage door was observed. Correction should involve a minor repair.

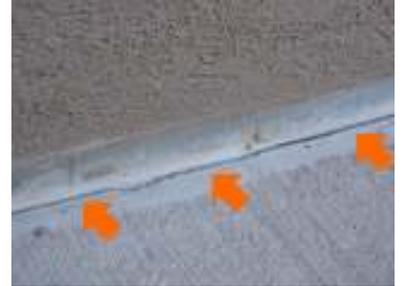
The front porch concrete pad has settled and pulled away from the house slightly. This has created a gap between the house and the porch. Although this is not a serious problem, it should be monitored over time to see if the movement continues. I would recommend that the gap be filled and caulked to prevent water entrance which could be promoting the problem.

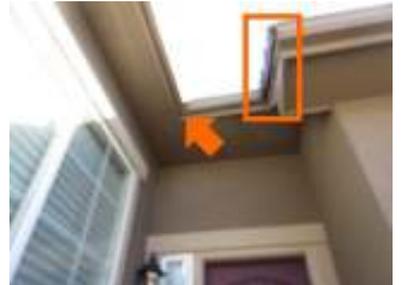
- The gutters were reported to be leaking at the joint above the entry door. The leaking joints should be repaired, patched and sealed.
- No kickout was observed to channel water away from the front door patio area. This is a convenience item as there will be water dripping on the patio step in front of the entry door. Correction would involve installing a kick out to divert water away from the edge of the house and into the gutter below.

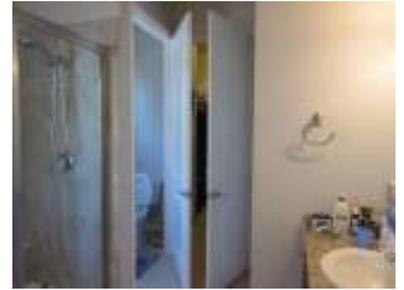
The configuration of the three doors in the master bedroom closet may cause doors/and or people to collide posing a safety hazard. Correction would involve switching the closet door to swing into the closet and away from the switch.

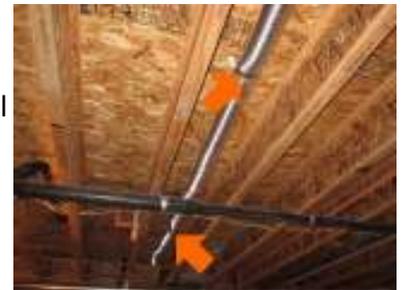
An aluminum flexible vent pipe has been used for the complete length of the dryer vent to the exterior and is partially crushed in some areas in the basement. It is good practice to install sheet metal vent pipe from the laundry room to the exterior vent. This type of vent reduces friction and does not clog as easily with lint. Only a short section of flexible pipe should be used behind the dryer. Consideration should be given to upgrading this dryer vent.
