INSPECTION SUMMARY AND REPORT

123 Anywhere St, Denver, CO

Inspection Date: xx/xx/yyyy

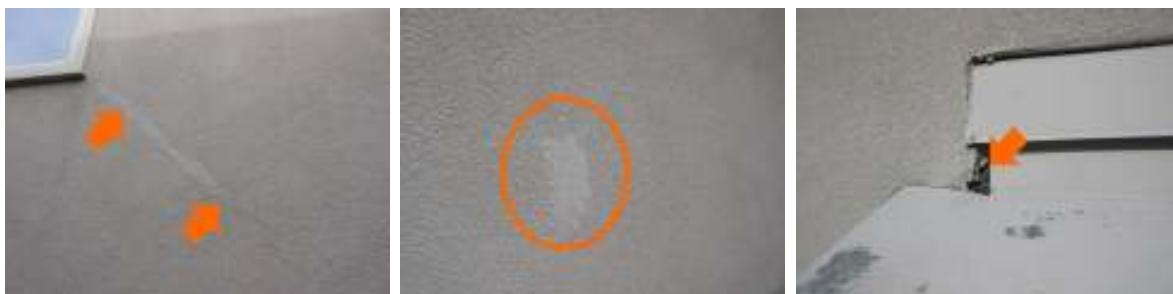
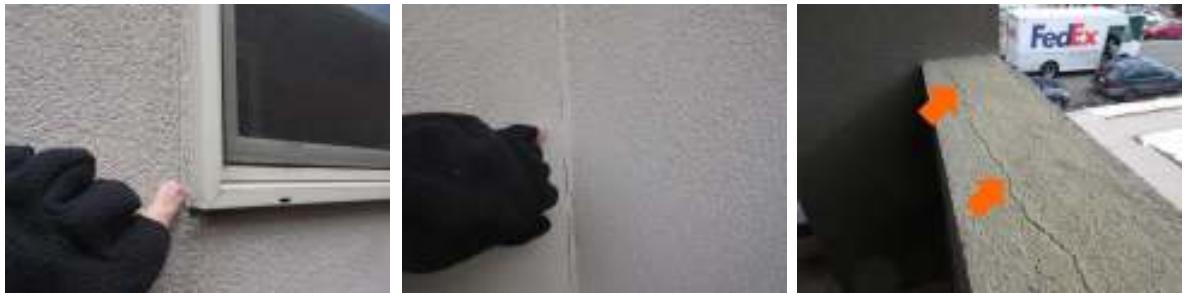
STUCCO CONDITION

The following deficiencies were observed on the stucco walls around the house:

- Many very thin (less than 1/32") long cracks were observed in the stucco walls around the house. This appears to be a type of "hardcoat" system but could not be verified. Some minor cracking on hardcoat systems is normal.
- Potential water entry gaps were observed around windows, wall mounted light fixtures and other wall penetrations around the house. It is proper practice to seal around all penetrations with special caulking specifically designed for stucco systems.
- Areas were observed most notably on the back patio separating wall and the balcony area where the stucco was installed flat onto a horizontal surface. This can lead to moisture entry.

Moisture damage with stucco systems can be hidden behind walls and corrections to stucco systems can be expensive. We recommend further inspection by a Stucco siding expert that can probe and identify moisture behind the walls. A proper stucco expert will draft a detailed correction plan that can then be completed by a stucco repair contractor. We also recommend that the stucco be regularly examined and potential water entry areas sealed as part of yearly maintenance.

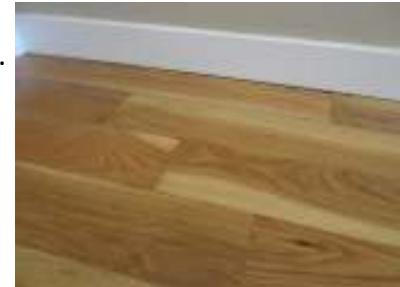
CUPPING ON WOOD FLOORS

Significant cupping was observed on the wood floor boards on the wood flooring on the main level of the house near the gas fireplace. This is likely a result of moisture entry at some point in the past. Asking the current owner about any documentation and warranty for the floor installation may be helpful. Correction will involve sanding and re-finishing the floor. If correction is desired, further consultation with a wood flooring specialist is recommended.

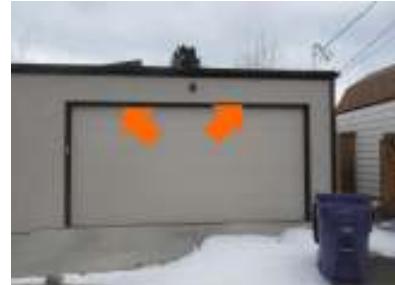
GARAGE DOOR TRIM

Several areas were observed where the paint on the door trim around the garage and the front door is peeling and deteriorating. It appears that no primer was initially used on this bare wood. Eventually this wood will rot and will need to be replaced. I recommend that these areas be scraped, sanded, caulked, primed and painted in the near future.

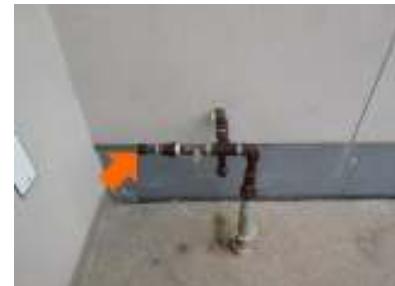
GAS LINE CAP:

Although a shut-off valve was present and in the "off" position, no cap was installed at the unused barbecue gas supply pipe at the exterior patio wall. If an object bumps against the valve handle, just a slight turn could leak potentially dangerous natural gas into the air. Correction should involve the installation of a threaded cap or the installation of a gas barbecue.

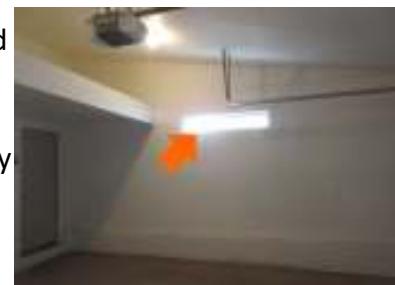
GARAGE WINDOW

Condensation, or residue caused from condensation, was observed between the two panes of glass in the garage window. This condition is an indication of a failed seal between the panes of glass. Correction typically requires replacement of the glass unit by a professional glass replacement contractor.

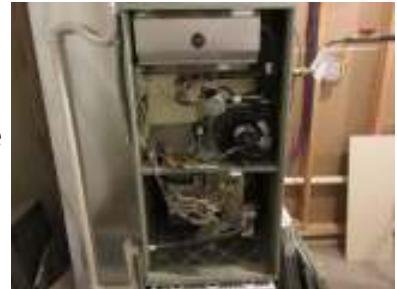
FURNACE

A moderate amount of dust was observed on the inside of the furnace cabinet, on the furnace blower motor and on the blower fan blades. These are indications that the furnace has not been serviced in quite some time. It is proper practice to have a furnace cleaned and serviced every 3-5 years. Although the furnace did respond to normal operating controls, we recommend that the furnace be disassembled, cleaned, inspected, repaired as necessary, tuned and certified safe by a professional heating system contractor.
