## NEW CONSTRUCTION INSPECTION REPORT

**123 New Construction Lane, Colorado**

**Inspection Date:** xx/xx/20xx

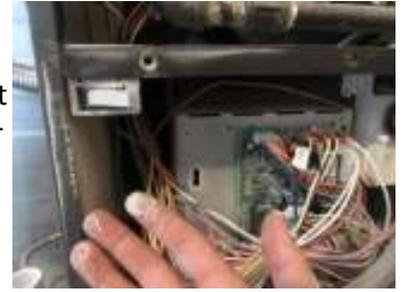
## VERY DIRTY FURNACE

The interior of the furnace cabinet and blower fan were observed to be coated with drywall/construction dust caused by operating the furnace during the construction of this new house. This dust can coat the inside walls of the heat exchanger, making the furnace run hotter than designed, possibly reducing the service life of the furnace, and increasing the chance of a breach in the wall of the heat exchanger which can allow Carbon Monoxide gasses to enter the living space. Proper correction will involve significant disassembly (to expose the heat exchanger) and cleaning of the entire furnace by a professional HVAC contractor.

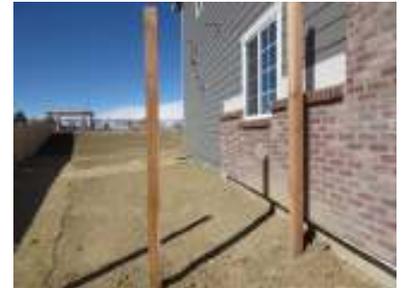
## FENCES INCOMPLETE

The fences were not completed at time of inspection. Correction would involve completing for privacy and security prior to final possession. The fences that were completed were observed to be properly installed and in good overall condition. No significant deficiencies were found.

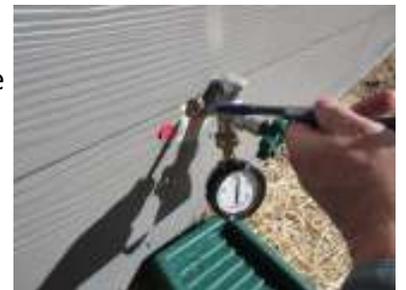
### *HOSE FAUCET:*

A very small amount of water was leaking from the anti-siphon device at the top of the faucet when the faucet was turned on at the left exterior of the house. Correction may involve minor repair or replacement of the faucet.

FAUCETS: A very small amount of water was leaking from the anti-siphon device at the top of the faucet when the faucet was turned on at the left exterior of the house. Correction may involve

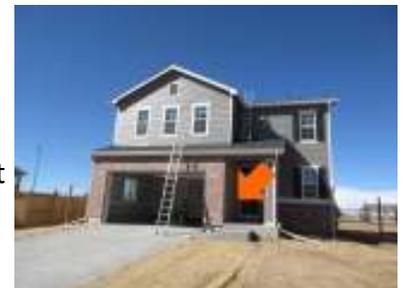
### *GFCI OUTLET:*

The outlet near the front door exterior was found to be wired with reverse polarity - the hot and neutral wires have been reversed where they are attached on the back of the outlet. Although most appliances will still work with the outlet wired this way, under some circumstances this can be a potential safety issue. Other outlets that were inaccessible for testing may also be wired incorrectly. Correction should involve further inspection and repair as necessary by a professional electrician.

**GFCI OUTLETS:** The outlet near the front door exterior was found to be wired with reverse polarity - the hot and neutral wires have been reversed where they are attached on the back of the outlet. Although most appliances will still work with the outlet wired this way, under some circumstances this can be a potential safety issue. Other outlets that were inaccessible for testing may also be wired incorrectly. Correction should involve further inspection and repair as necessary by a professional electrician.

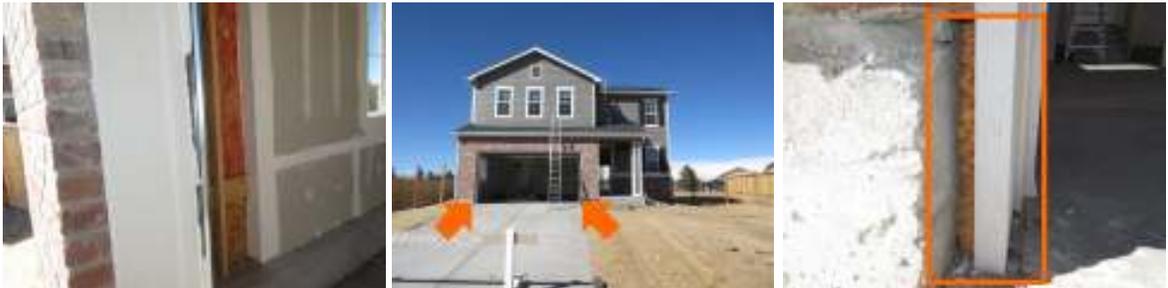
### *AUTO DOOR CONDITION:*

- The vinyl weather stripping on the left of the garage door was damaged. Correction will involve replacement of this gasket.
- Gaps were observed between the framing and the garage door wood trim boards on both sides of the garage door. Although these gaps were sealed with spray foam insulation, a more permanent (wood or metal) material would protect the garage from small rodents.

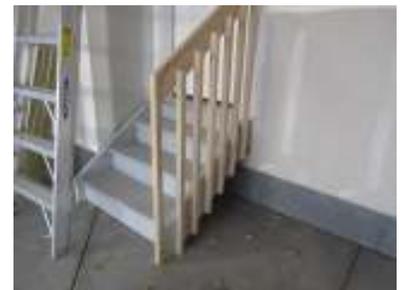
### *STAIRWAY:*

No paint was observed on the bare wood stairway railing leading from the garage to the house. It is proper practice for this wood to be painted.

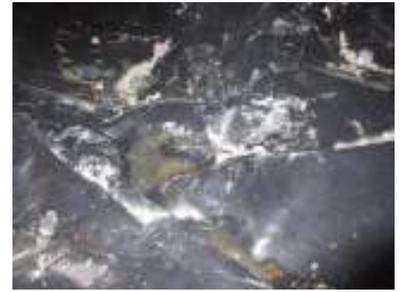
### **CRAWL SPACE MOISTURE CONDITION:**

Two small water puddles were observed on the vapor barrier. The source of this water could not be determined and did not appear to be active. This water could have come from the sump pit with no discharge or this could have been a bi-product of construction. Correction would involve monitoring these areas for further leakage, correcting the source as necessary.

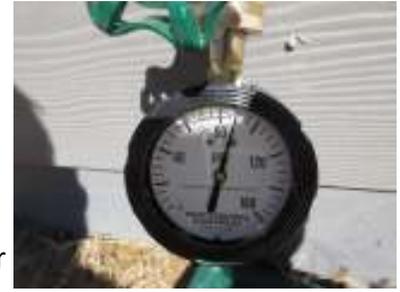
### **WATER PRESSURE**

The static water pressure at one of the outdoor faucets was tested and found to be between 80 to 85 psi which is an indication of the pressure in the entire house water supply system. The recommended water pressure for residential homes is between 40 and 70 psi. Although most modern appliances are rated for up to 120 psi, excessive pressure can result in damage to plumbing fixtures, appliances, plumbing pipes and have a greater potential for flooding problems. A pressure regulator, with a maximum range of 75 psi, was observed where the pipe enters the house in the basement. The high pressure in the system is an indication that the regulator needs to be adjusted. Correction typically requires adjustment by a professional plumber or handyman.

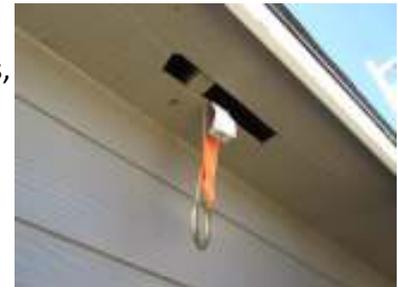
### **SOFFIT OPENING**

There is an opening under the roof overhang where the safety hook was installed. The opening should be sealed to prevent birds, insects and rodents from getting into the structure.

CONDITION: There is an opening under the roof overhang where the safety hook was installed. The opening should be sealed to prevent birds, insects and rodents from getting into the structure.
