WARRANTY INSPECTION REPORT

123 Anywhere St, Castle Rock, CO

Inspection Date: xx/xx/xxxx

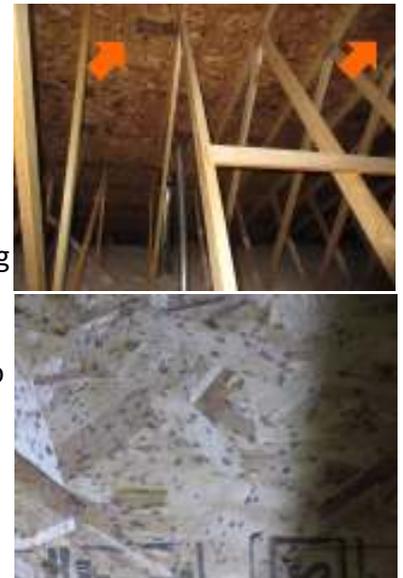
ATTIC PLYWOOD

Black, mold like material was observed on the underside of some of the wood decking in the attic area. This condition is typically due to the plywood material sitting outside in the elements during construction and the mold does not continue to grow or cause a problem once the plywood decking is installed. Testing to confirm if this is truly mold is beyond the scope of this inspection. In extreme cases, spores from the mold can enter the living area and, depending on the type of mold, may adversely affect the health of the people living in the house. Mold needs a continuous source of moisture to grow. When the moisture source is eliminated, the mold can go into a hibernation stage and stop creating spores. It is possible that this is inactive mold. Further consultation and possible testing can be performed by a professional Industrial Hygienist or mold testing contractor. It will also be helpful to have this documentation when selling the house in the future.

OBSERVATIONS:	Black, mold like material was observed on the underside of some of the wood decking in the attic area. This condition is typically due to the plywood material sitting outside in the elements during construction and the mold does not continue to grow or cause a problem once the plywood decking is installed. Testing to confirm if this is truly mold is beyond the scope of this inspection. In extreme cases, spores from the mold can enter the living area and, depending on the type of mold, may adversely affect the health of the people living in the house. Mold needs a continuous source of moisture to grow. When the moisture source is eliminated, the mold can go into a hibernation stage and stop creating spores. It is possible that this is inactive mold. Further consultation and possible testing can be performed by a professional Industrial Hygienist or mold testing contractor. It will also be helpful to have this documentation when selling the house in the future.

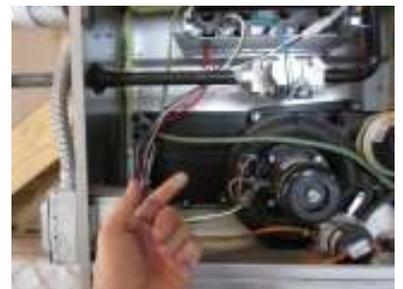
FURNACE

The interior of the furnace blower fan blades were observed to be coated with drywall/construction dust caused by operating the furnace during the construction of this new house. This dust can coat the inside walls of the heat exchanger, making the furnace run hotter than designed, possibly reducing the service life of the furnace, and increasing the chance of a breach in the wall of the heat exchanger which can allow Carbon Monoxide gasses to enter the living space. Proper correction will involve significant disassembly (to expose the heat exchanger) and cleaning of the entire furnace by a professional HVAC contractor.

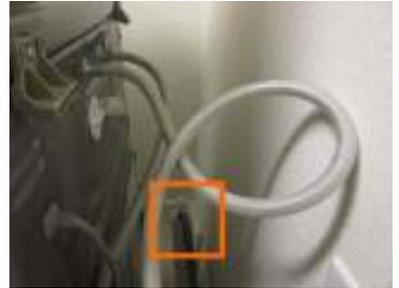
LAUNDRY DRAIN

The washing machine was draining into the drain pipe designed for the laundry sink. It is unlikely that this drain pipe has a trap to ensure that sewer gases are not escaping to the living area. The proper drainage point for the washer is located on the wall in between the hot and cold water supply for the washer. It is "hidden" underneath a removable round knock out in the plastic laundry outlet box. The pipe located here likely has a trap to ensure no sewer gases enter the living area. Once the drain pipe is relocated the laundry sink pipe should be sealed until a laundry sink can be installed.

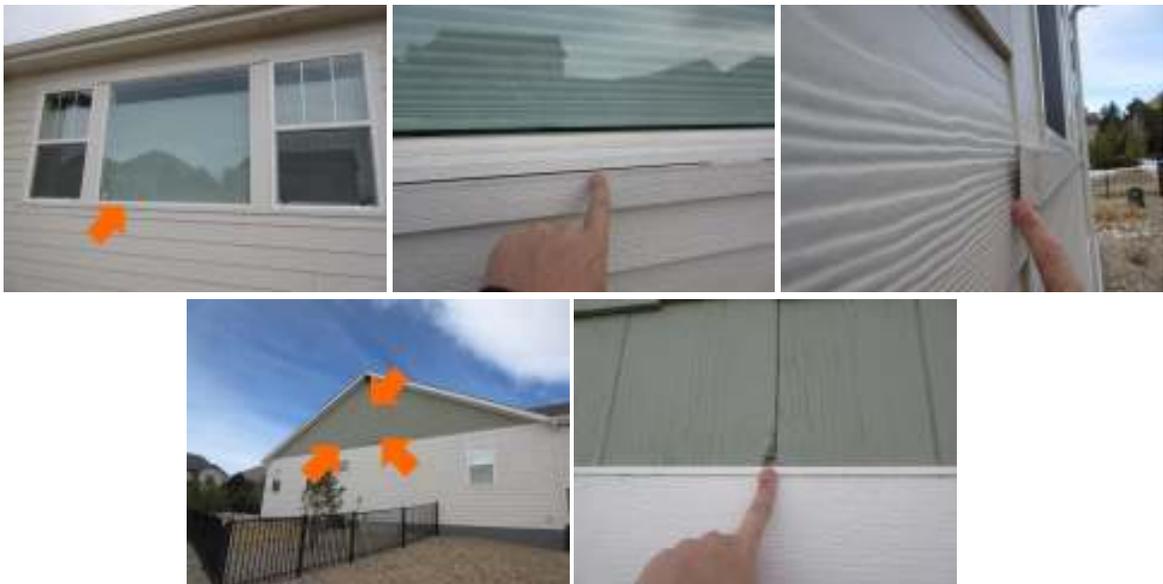
PAINT AND FINISHES CONDITION:

- Potential water entry gaps (cracks) were observed in some of the caulking joints of the hardboard siding and trim around the house - most notably at the bottom corners of the windows in the rear. This is a natural occurrence that happens over time when the materials expand and contract with the different temperatures. Water entering these areas will cause permanent swelling damage.
- A small amount of peeling paint or tape was observed around the house most notably at the left gable wall.
- Two hardboard wall shingles appeared to be damaged at the left of the house and in the front of the house adjacent to the front bedroom window.

Correction would involve filling water entry areas with caulk and repainting affected areas around the house.

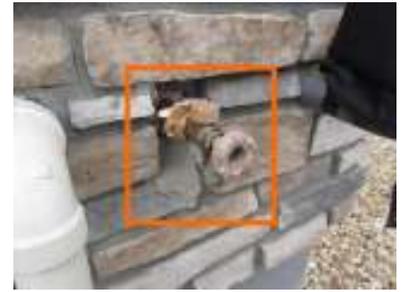
HOSE FAUCET:

The faucet at the left of the house was loose where it should be attached to the wall. In addition, 2-3 inches of copper pipe has been exposed. Correction typically requires sealing the open area in the veneer and installation of two screws into the solid wall.

FAUCETS: The faucet at the left of the house was loose where it should be attached to the wall. In addition, 2-3 inches of copper pipe has been exposed. Correction typically requires sealing the open area in the veneer and installation of two screws into the solid wall.

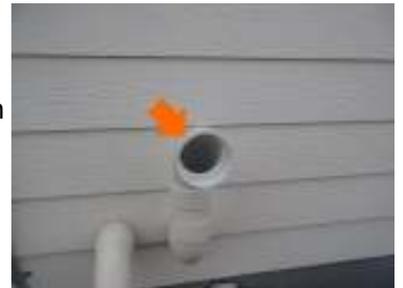
WALL VENT:

No screen is installed at the furnace wall vent cap at the left of the house. A screen will keep pests from entering the pipe. Correction will involve the installation of a screen or replacement of the cap with a screened cap.

WALL VENTS:	No screen is installed at the furnace wall vent cap at the left of the house. A screen will keep pests from entering the pipe. Correction will involve the installation of a screen or replacement of the cap with a screened cap.
-------------	--

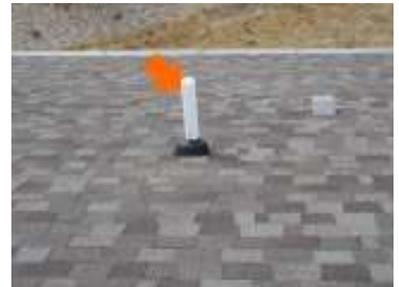
PLUMBING VENT:

White plastic plumbing vent pipes were observed extending up through the roof. Eventually these PVC pipes will discolor and deteriorate due to sun exposure. It is proper practice to paint the pipes with an exterior grade paint.

PLUMBING VENTS: White plastic plumbing vent pipes were observed extending up through the roof. Eventually these PVC pipes will discolor and deteriorate due to sun exposure. It is proper practice to paint the pipes with an exterior grade paint.

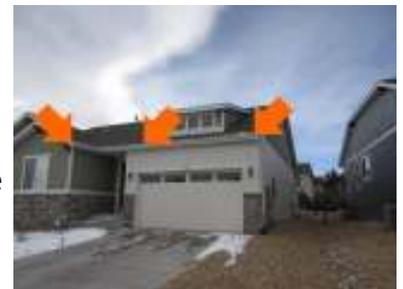
GUTTER SLOPE:

The gutter at the front of the house is not sloping properly towards the downspout and water was observed standing in the gutter. This will cause the gutter to over flow water in times of heavy rain and will trap standing water which will result in the gutter and trim surrounding it to deteriorate prematurely. Correction should involve repair by a gutter service contractor.

CONDITION: The gutter at the front of the house is not sloping properly towards the downspout and water was observed standing in the gutter. This will cause the gutter to overflow water in times of heavy rain and will trap standing water which will result in the gutter and trim surrounding it to deteriorate prematurely. Correction should involve repair by a gutter service contractor.

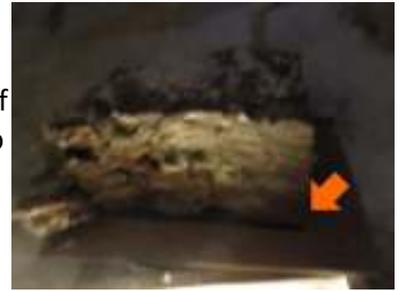
ATTIC ACCESS CONDITION

- A piece of fiberglass insulation that was originally on the top of the attic hatch door has been pushed off and is lying on the floor of the attic. It also appeared that the bat was not of sufficient size to insulate the opening. It is proper practice to install a piece of fiberglass batting insulation attached to the top of the access hatch door to insulate the door. Correction will involve re-installation and proper attachment of the correct size insulation.
- The attic hatch door was not textured or painted. Typical practice is to texture and paint the access hatch door to match the surrounding drywall for a better appearance.

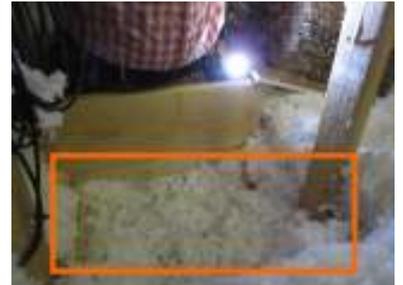
ATTIC INSULATION:

The attic space has only a minimal amount of insulation in a small area directly adjacent to the access hatch. Consideration should be given to installing additional insulation in that area to improve the energy efficiency of this home.

INSULATION TYPE:	Loose-fill Fiberglass insulation.
INSULATION CONDITION:	The attic space has only a minimal amount of insulation directly adjacent to the access hatch. Consideration should be given to installing additional insulation in that area to improve the energy efficiency of this home.
DEPTH AND R-FACTOR:	The average insulation level was measured at approximately 13" - 16" = R-44. Currently the Department of Energy recommends R-49 insulation levels for new home attics - approximately 16" deep of loose fill fiberglass.
