INSPECTION SUMMARY AND REPORT

123 Anywhere St., Denver, CO

Inspection Date: xx/xx/xxx

Prepared For: John Q. Homebuyer

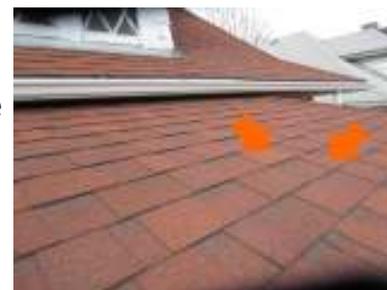
Small, 1/8" diameter or less, spots of missing granular material were observed consistently across much of the roof covering. This "blistering" appears to be the result of old age and could partially be caused by minor hail damage. In our opinion this roof covering will perform properly for several more years, however, some insurance companies will not insure a roof covering in this condition. We recommend consulting with your homeowners insurance company and/or obtaining a 5 year roof certification by a professional roofing contractor.

It is possible that this roof covering may not achieve its full life expectancy due to a lack of attic ventilation. Temperatures of over 150 degrees are common in poorly vented old house attic spaces on hot summer days. These high temperatures can "bake" the roof covering and shorten its life. It is recommended that the attic ventilation be improved when the roof covering is replaced.

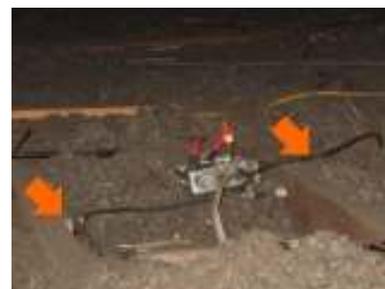
A significant amount of electrified, very old "Knob & Tube" electrical wiring was observed throughout the attic space. This wiring likely provides electricity to many or all of the ungrounded outlets, light switches, and light fixtures on the main level of the house. In some rare cases, this type of wiring can be a fire hazard. Some homeowners insurance companies may not insure a house with this type of wiring.

The wiring in the attic is designed to cool with surrounding air and should not be covered with insulation. Current common practice is to replace the old wiring with modern Romex wiring. We recommend further inspection and consultation with a professional electrician. We also recommend checking with your homeowners insurance to see if this type of wiring will affect your

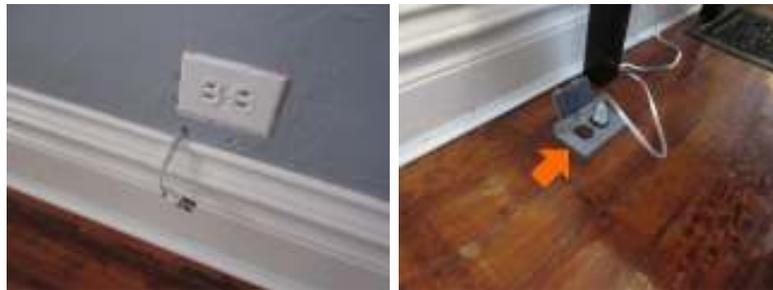
- Several light switches in the utility area was found at the front wall of the basement main room where the controlled light fixture, outlet or appliance was not identified.

- A minimum number of electrical outlets were observed in some areas of this house. It is current proper practice in new homes to have outlets installed so that no point along the wall is more than 6' away from an outlet (2' away at kitchen countertops). This is a potential inconvenience and possibly a safety issue if extension cords are used.

- A tested outlet in the basement bar area was found to be wired with reverse polarity - the hot and neutral wires have been reversed where they are attached on the back of the outlet. Although most appliances will still work with the outlet wired this way, under some circumstances this can be a potential safety issue. Other outlets that were inaccessible for testing may also be wired incorrectly.

- Several unground 3-prong outlets were observed in the house and garage. This gives the impression that these outlets are grounded when they are not. Correction will involve grounding the outlets (normally consisting of installing new wiring from the main electrical panel) or replacing the outlets with 2-prong outlets.

- Outdoor receptacles are floor-mounted in the living area. Outdoor receptacles are inappropriate for this application. Replacement with an approved, recessed receptacles is recommended.

These are potential fire, shock and safety hazards. We recommend further inspection and correction as necessary by a professional electrician.

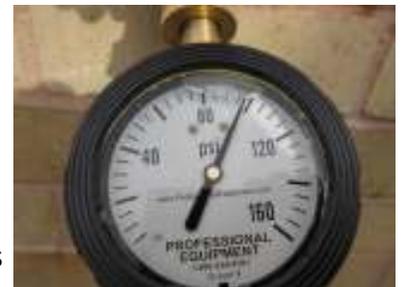
The static water pressure at an outdoor faucet was tested and found to be between 95 to 100 psi. This is an indication of the pressure throughout the entire water supply plumbing system in the house. The recommended water pressure for residential homes should be between 40 and 75 psi. Excessive pressure can result in damage to plumbing fixtures, appliances, plumbing pipes and have a greater potential for flooding problems. Correction of this condition involves the installation of a a pressure regulator by a professional plumber.

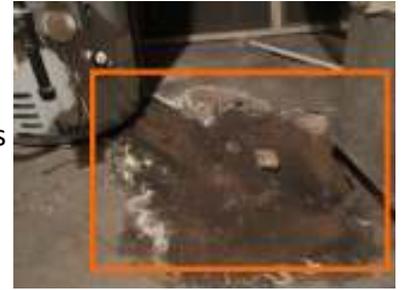
The water heater was found to be 12 years old, based on the date code in the serial number. The typical life of a water heater is 12-15 years. The water heater is old and is nearing the end of its expected service life. Leakage was observed at the water heater. This indicates that the water heater is most likely at the end of its life. Correction would involve repair or replacement by a qualified plumber.

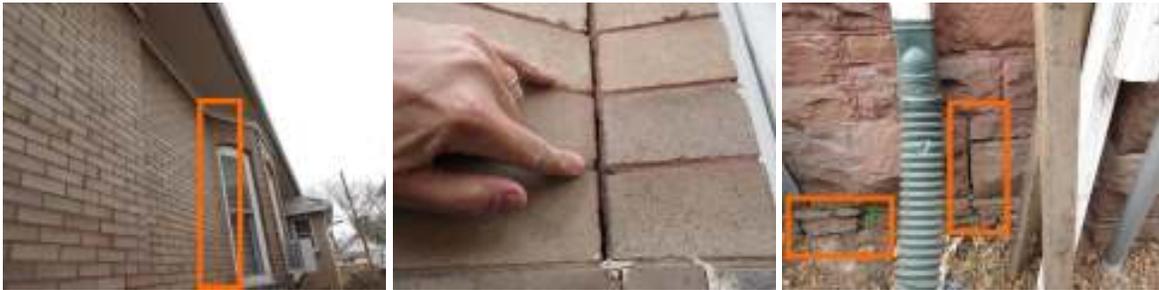
The brick exterior generally appears to be in good condition for its age. The mortar was missing from in between the bricks at many small areas around the house. Eventually this will allow the bricks to loosen and fall out of the walls. Correction involves installing new mortar into the joints, a process referred to as "re-pointing" or "tuck-pointing". Proper re-pointing is an art and should be performed by a highly qualified masonry repair contractor.

BRICK: The brick exterior generally appears to be in good condition for its age. The mortar was missing from in between the bricks at many small areas around the house. Eventually this will allow the bricks to loosen and fall out of the walls. Correction involves installing new mortar into the joints, a process referred to as "re-pointing" or "tuck-pointing". Proper re-pointing is an art and should be performed by a highly qualified masonry repair contractor.

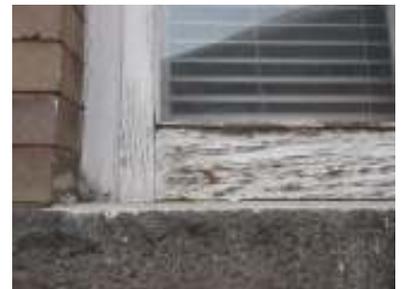
Several areas were observed where the paint on the window and door trim is peeling and deteriorating. It appears that no primer was initially used on this bare wood. Eventually this wood will rot and will need to be replaced. I recommend that these areas be scraped, sanded, caulked, primed and painted in the near future.

CONDITION: Several areas were observed where the paint on the window and door trim is peeling and deteriorating. It appears that no primer was initially used on this bare wood. Eventually this wood will rot and will need to be replaced. I recommend that these areas be scraped, sanded, caulked, primed and painted in the near future.

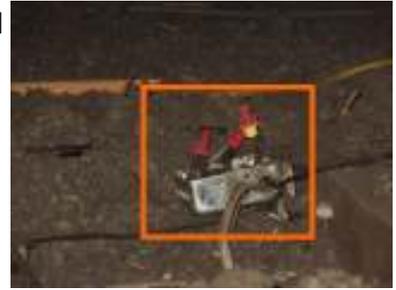
One open junction box was observed in the attic. This is a potential shock and fire hazard. It is proper practice to have all wire connections enclosed inside of a covered electrical junction box. Correction will involve installing proper covers over this and any other open junction boxes.

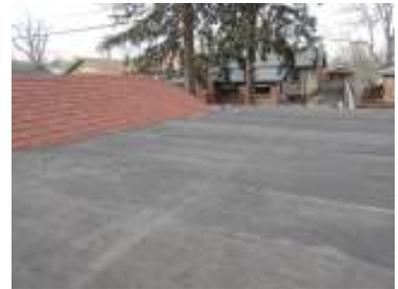
The glass was cracked in the one of the garage windows. Replacement should be considered.

The garage roof is old and worn. Although it is still serviceable and not leaking, expect to replace the roof within the next few years.

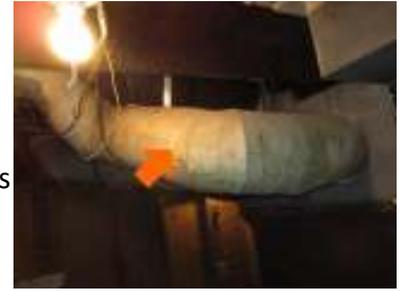
The vent connector is sealed with tape commonly containing asbestos. Sealing this material is a technique often advised by experts for this condition. Additional information could be obtained from an asbestos abatement contractor. Testing materials for actual asbestos content can only be done in a laboratory and is beyond the scope of this inspection.

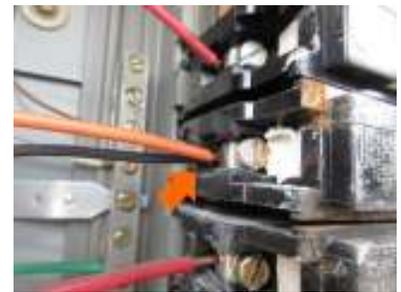
Two wires were found to be connected to a single circuit breaker where only one wire should be connected in the main electrical panel at the rear of the house. This breaker is now protecting two separate circuits. It is proper practice to have only one wire connected to each breaker. Correction should involve repair by a professional electrician.
