INSPECTION SUMMARY AND REPORT

123 Anywhere St, Denver, CO

Inspection Date: xx/xx/yyyy

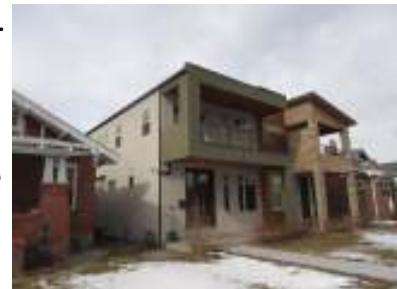
BUILDING HEIGHT

- Due to the height of the building, the roof was not inspected. Full roof inspection is scheduled for a later date. If significant issues are observed, an addendum to this report will be issued.
- The central AC condenser unit appeared to be located on the roof. Due to the height of the building, the AC was not inspected. Full AC inspection is scheduled for a later date. If significant issues are observed, an addendum to this report will be issued.
